# COMCORD - BRIDGE

# Comcord

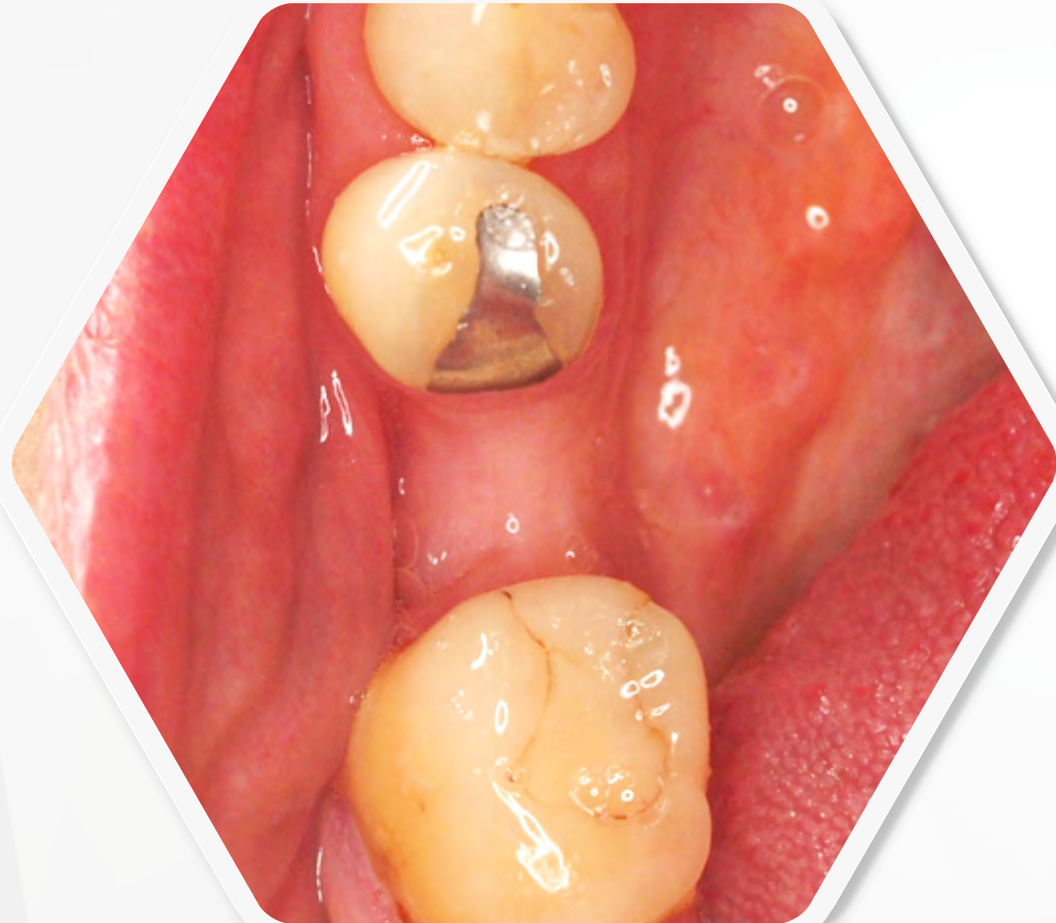
A missing tooth 36.

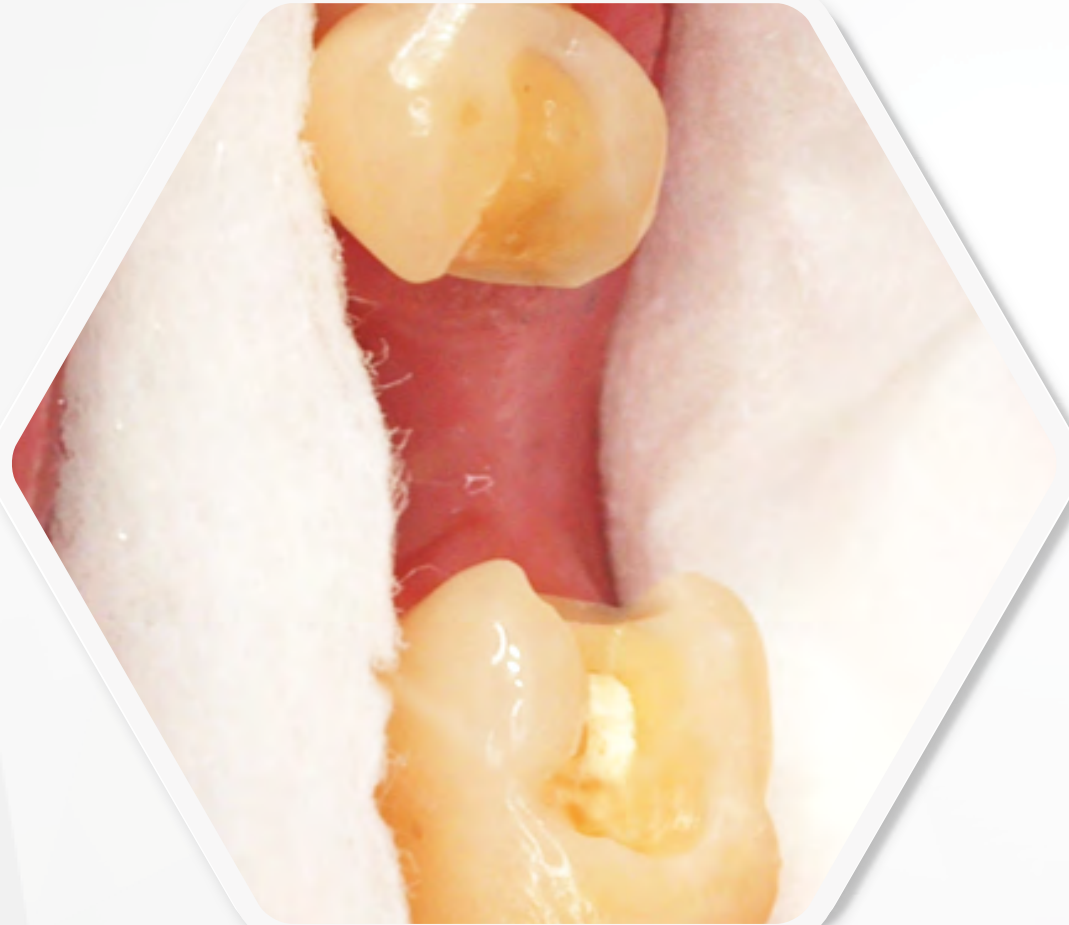
Preparations on the adjacent teeth.

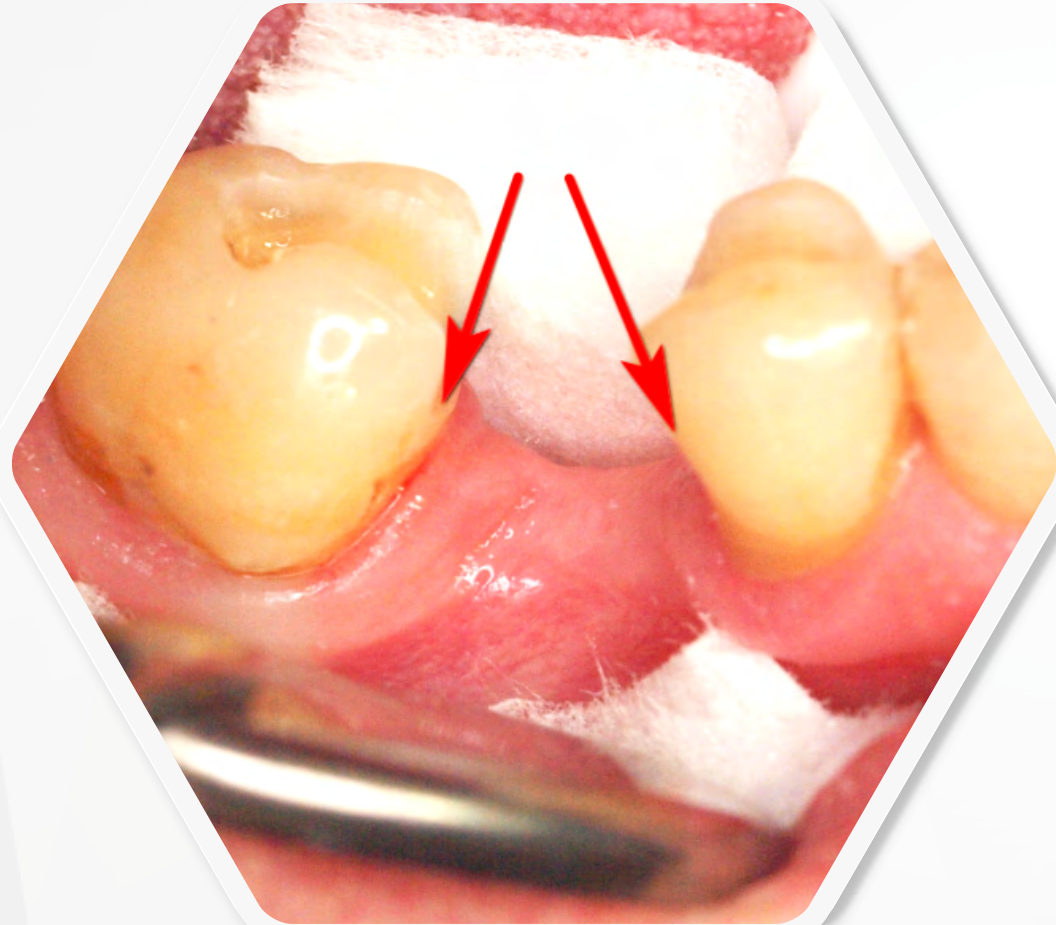
The restoration cannot be done using an indirect method as it would require a very extensive (and unnecessary) preparation of the adjacent teeth..

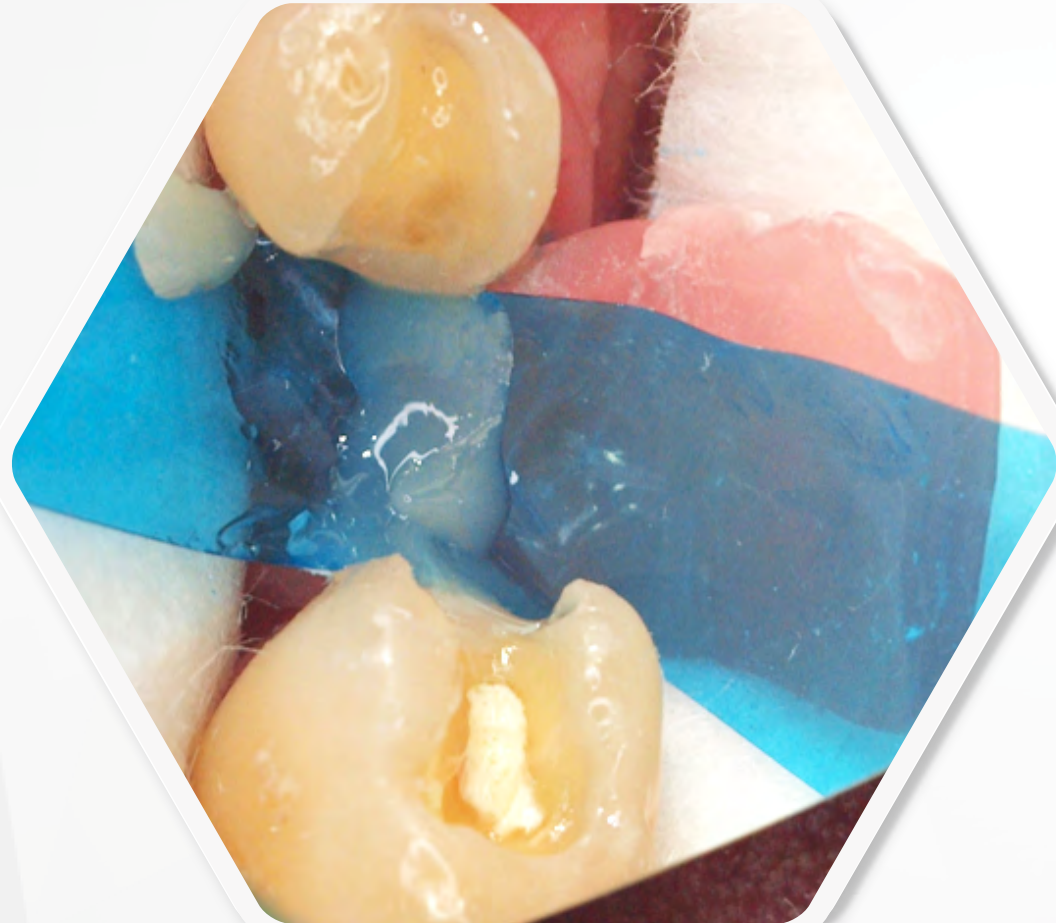
Tooth surfaces isolation.

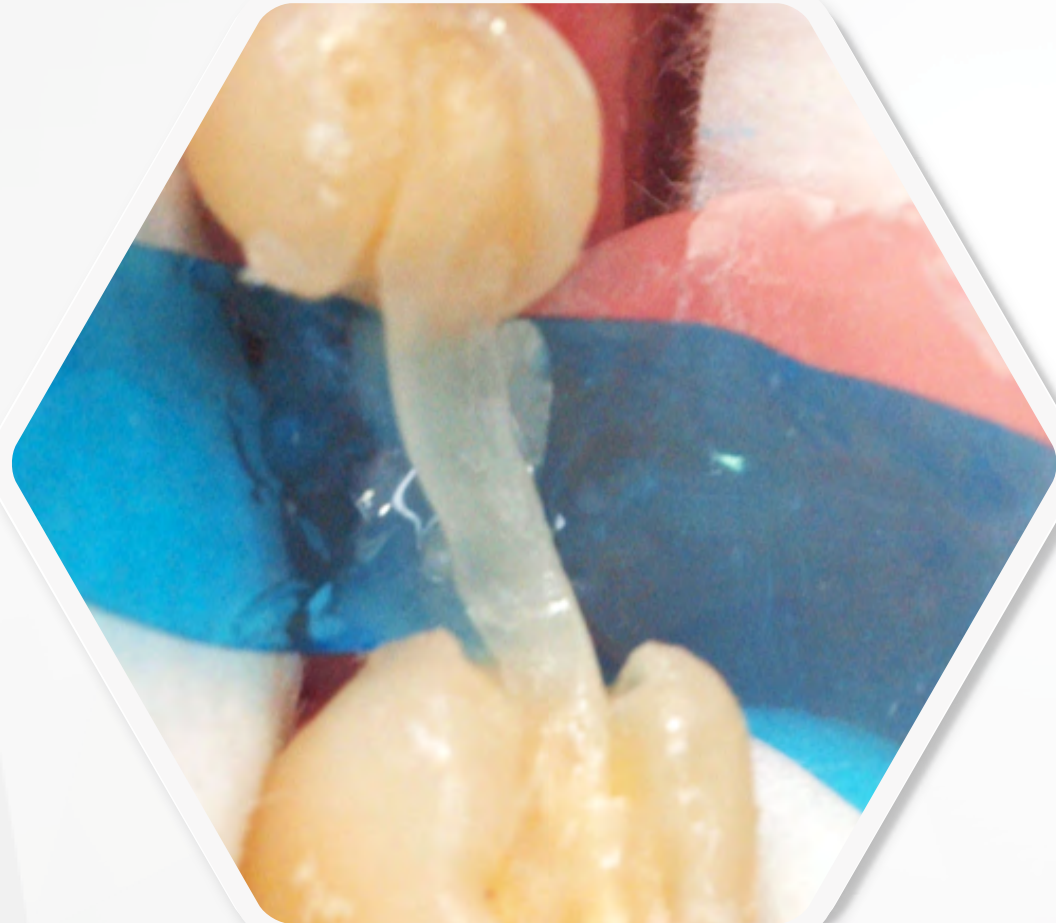
The first COMCORD stripe in place.

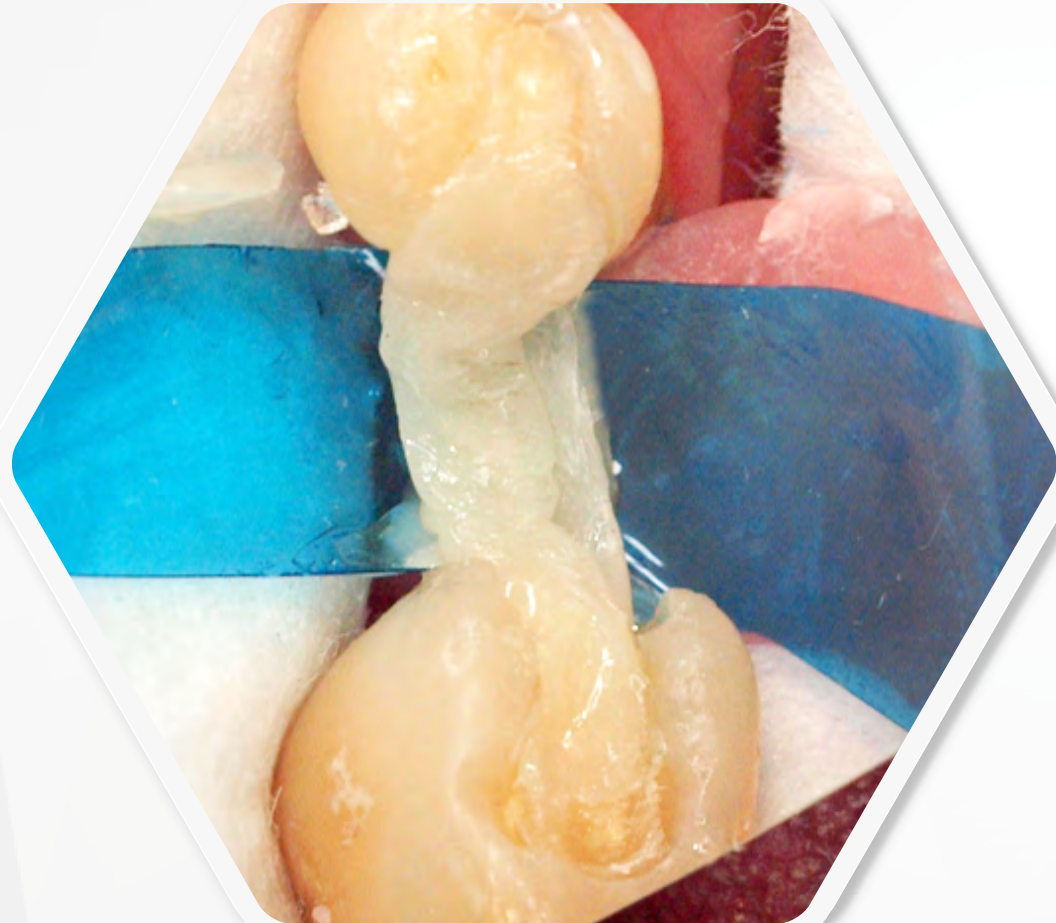
The second COMCORD stripe  
in place.

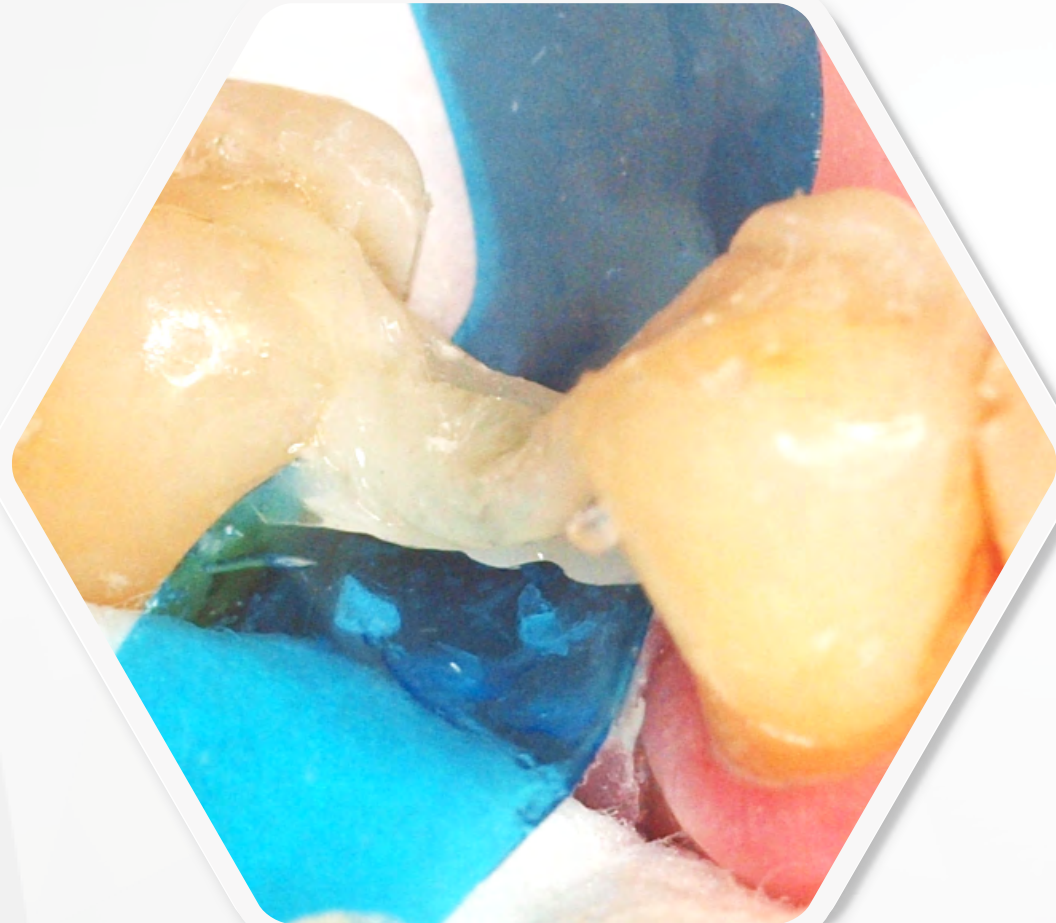
The bridge during modeling  
(vestibular view).

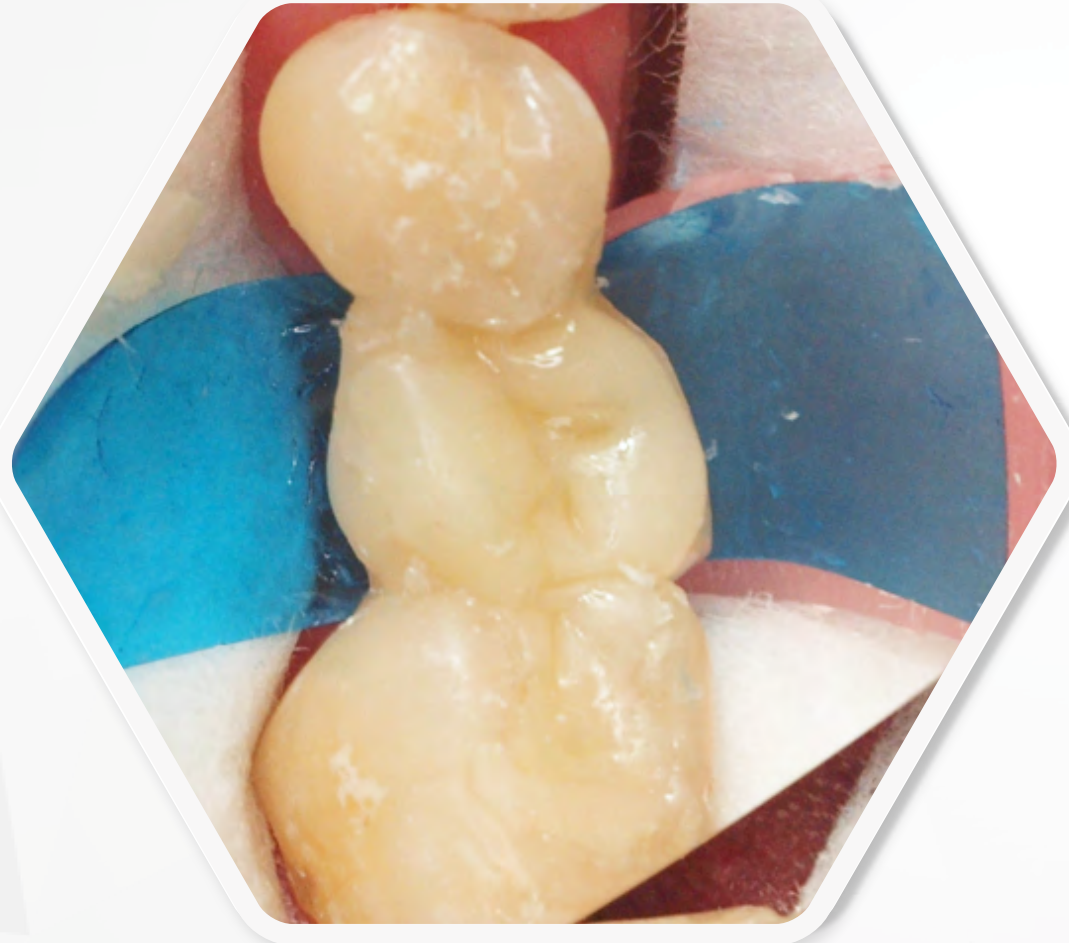
The bridge during modeling (occlusal view).

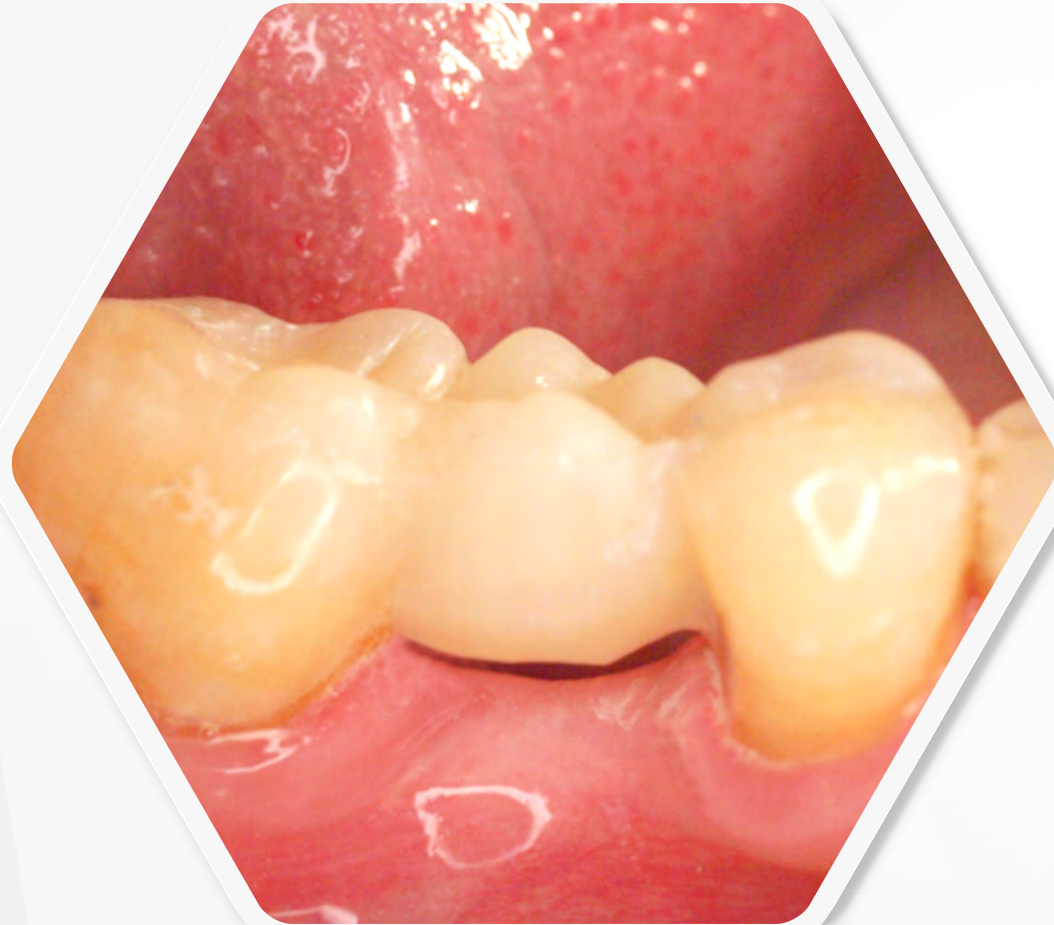
BRIDGE 35-37 M8

A finished bridge (vestibular view).

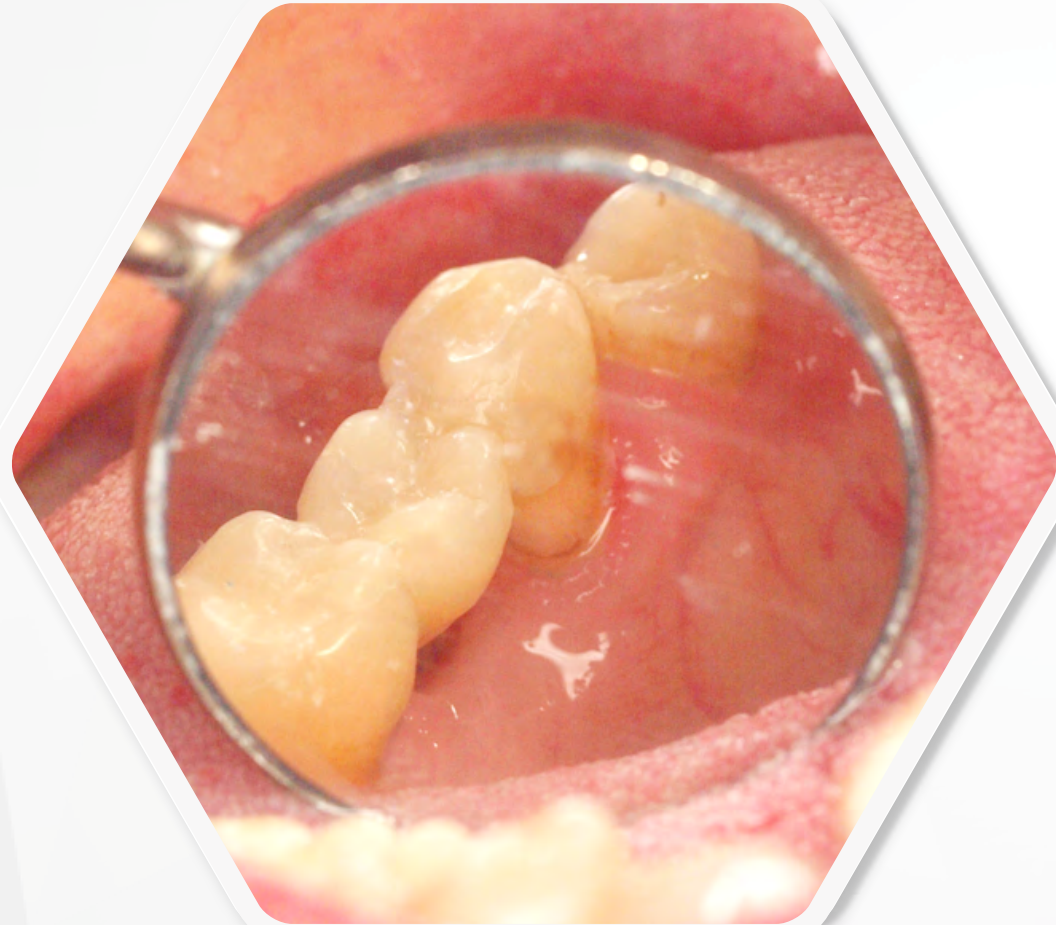
A finished bridge (occlusal view).

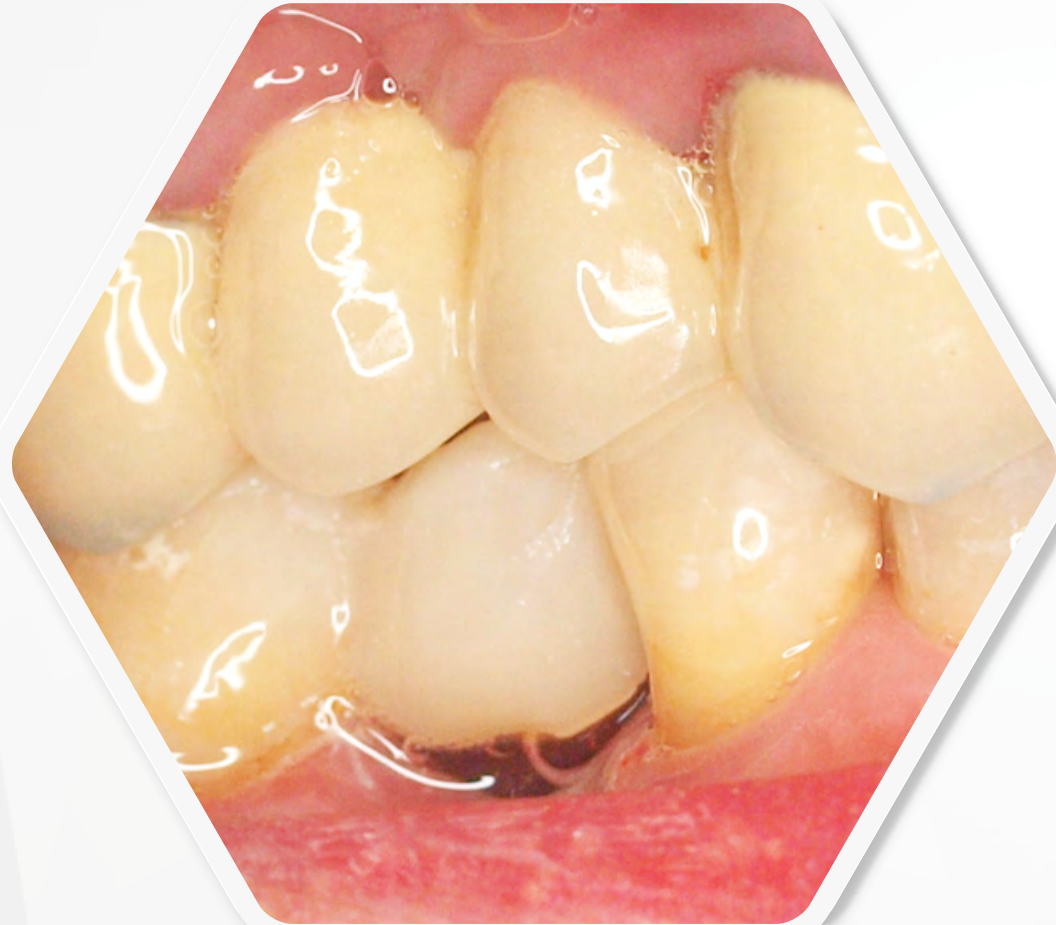
BRIDGE 35-37 M8

A finished bridge.

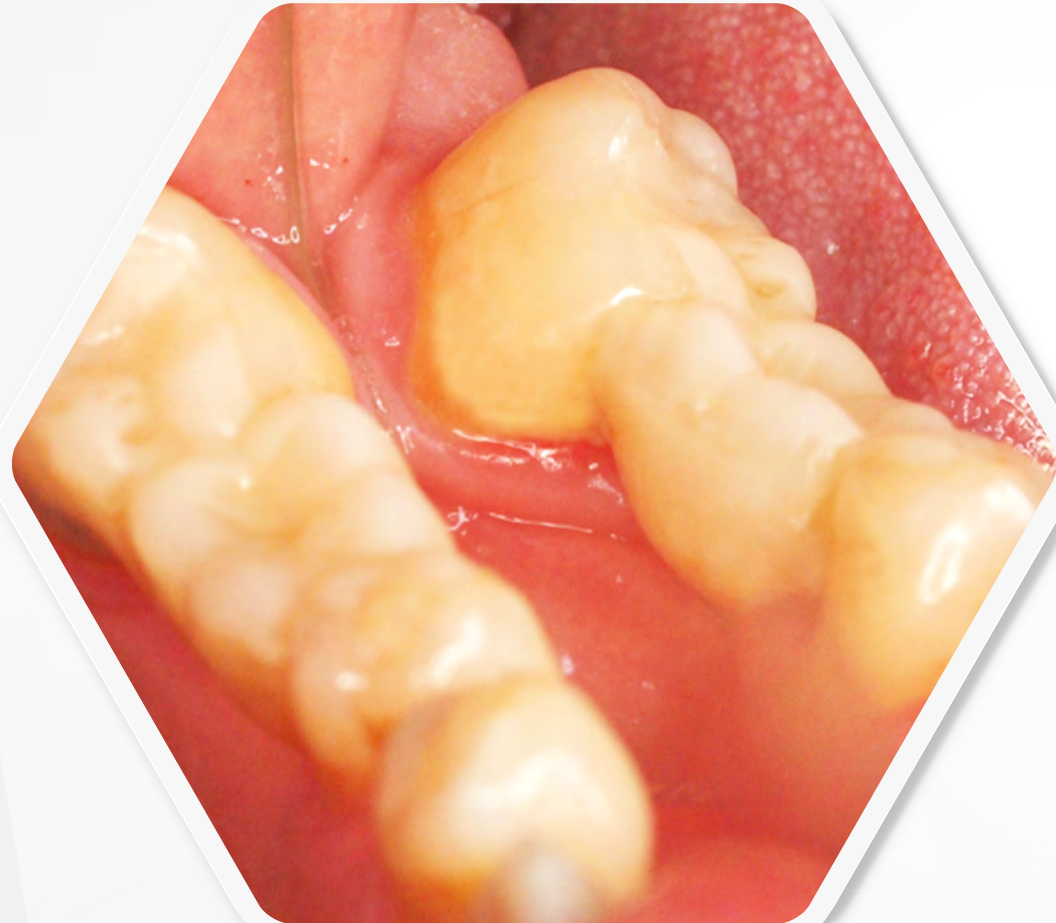
BRIDGE 35-37 M8

A finished bridge.
